**STAFF REPORT**

Subject: Cohen Trust Land Capability Challenge  
3195 Edgewater Drive, Placer County, California  
APN: 093-072-001, TRPA File No: LCAP2023-0352

Attachment B  
Site Photographs (December 13, 2023)

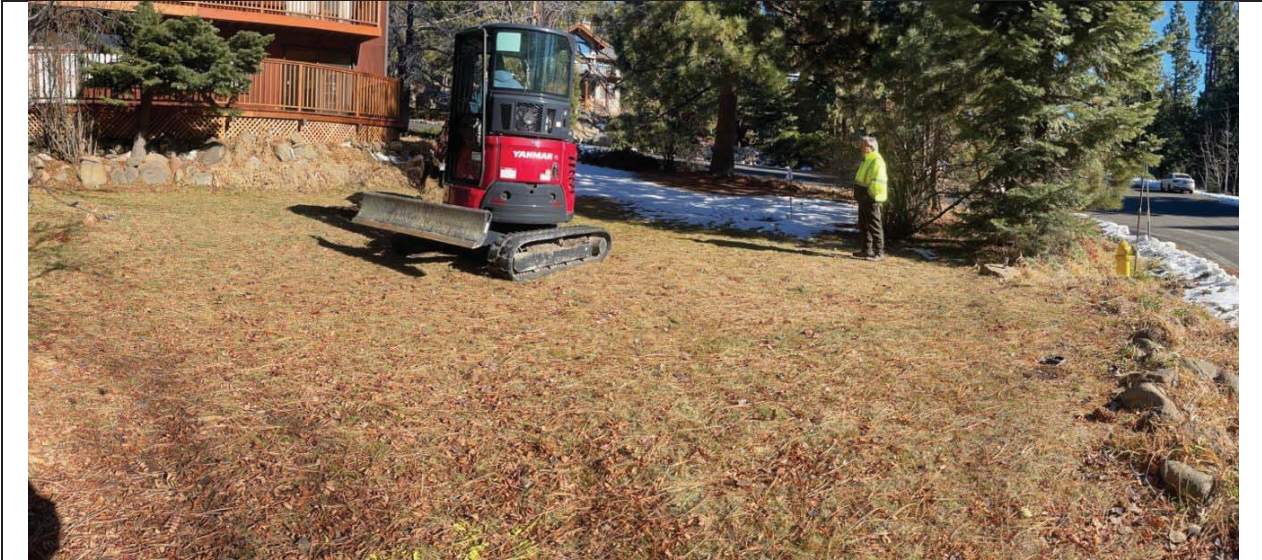
Photo 1 – View south-center of property where mini-excavator is positioning to dig the soil pit. The land surface drops off abruptly (lower right), because it was over-steepened from street construction (circa 1970s). Vegetation consists of Jeffrey pine, white fir, ornamental trees and shrubs, plus lawn.

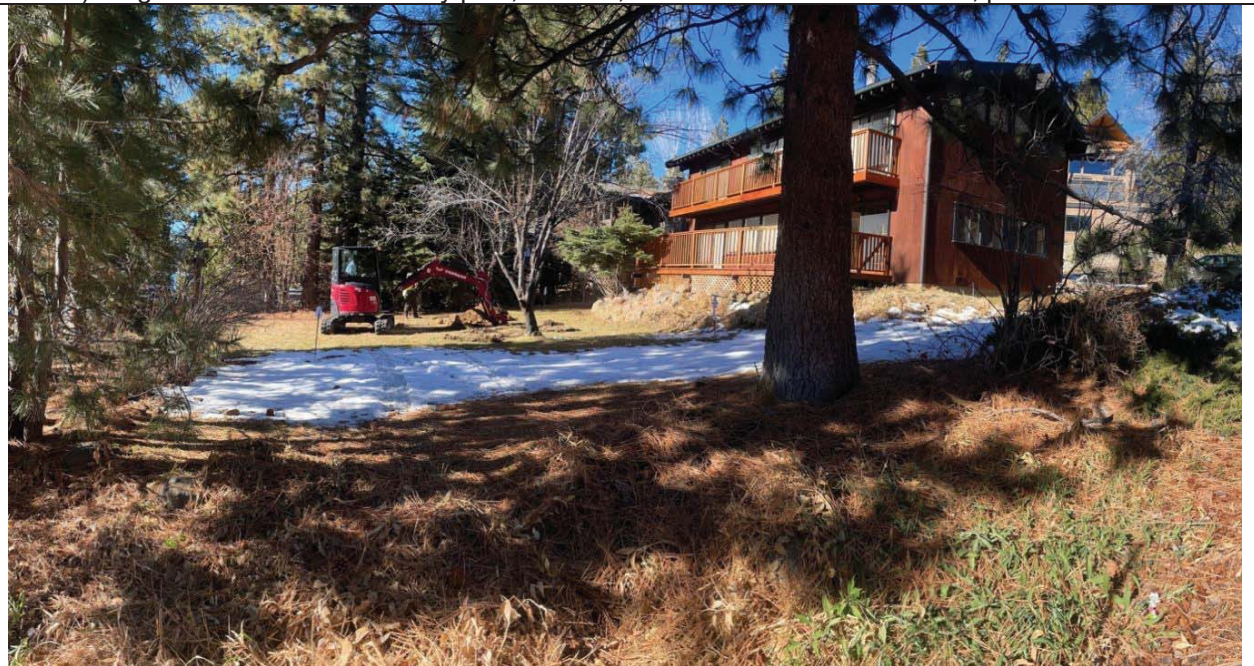
Photo 2 – View west to northwest from southeast property corner (Lassen Drive situated behind photographer). The foreground shows the roadside ditch, which is partially vegetated, but lacking any SEZ species. While there is an artificially steepened slope along Edgewater Drive (beyond left side of photo); however, TRPA evaluates historic slope condition for land capability purposes.

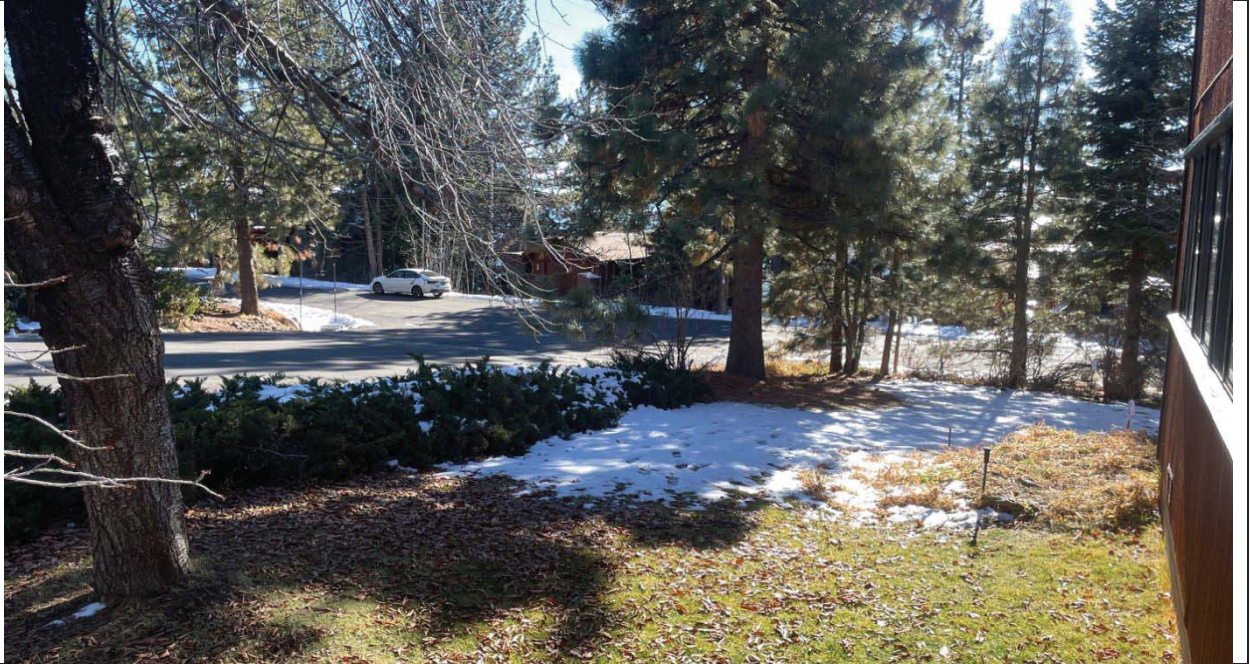
Photo 3 – View to southeast at southeast edge of parcel. The yard along Edgewater Drive (upper background) and Lassen Drive (left side of photo) is mostly landscaped with lawn, plus ornamental shrubs and trees. Along with the deep but rocky soils, the property has 9 to 14% slopes. As such the land capability for this parcel qualifies as Class 6.

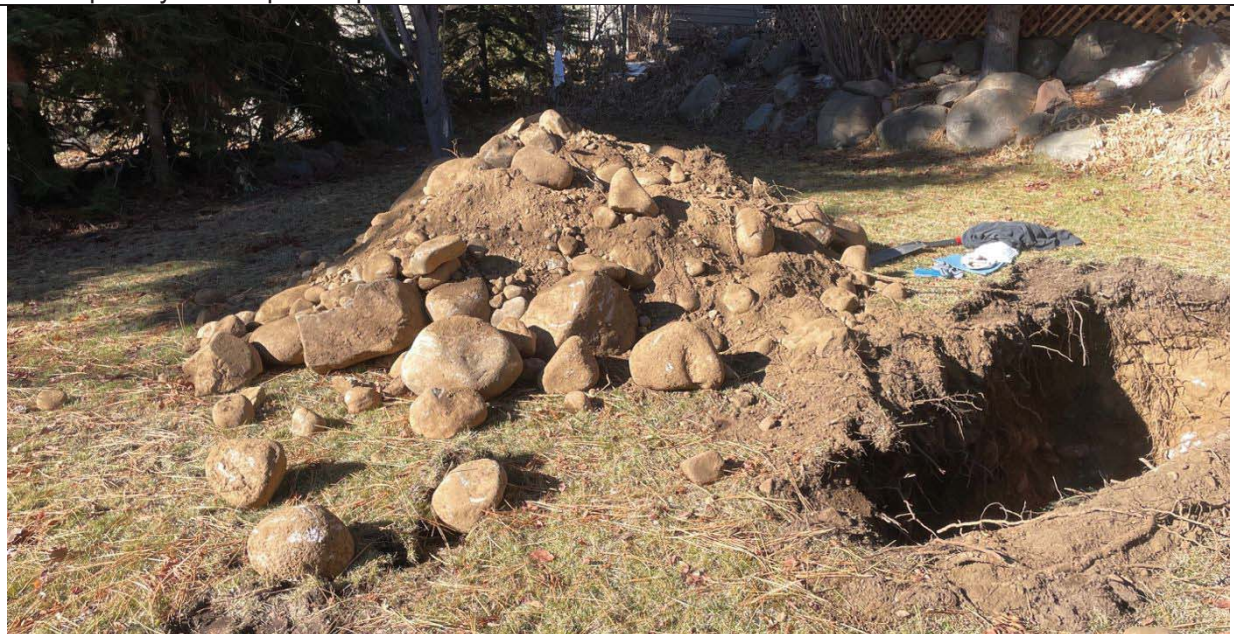
Photo 4 – View to northwest at south portion of parcel where Test Pit no. 1 was excavated by backhoe. The pit was located about 35 feet north of Edgewater Drive and 40 feet east of the west property line. Slopes are 9% in this vicinity. Side cast material for the test pit shows the rounded stones and boulders that increase with depth (no root restriction nor evidence of seasonal water table).

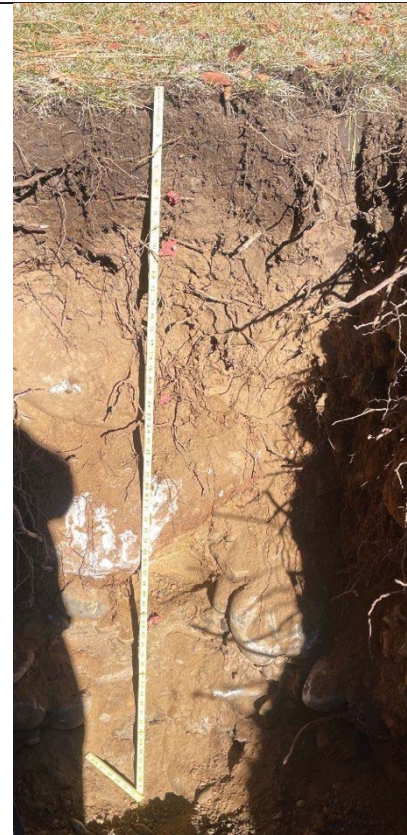
Photo 5 – Close-up view of Test Pit no. 1 showing gravelly-sandy surface layer with many fine and medium roots. Fine roots extend into lower part of profile (60 in. depth). The rockiness of the soil becomes stony and bouldery at 25 inches and increases with depth. These coarse fragments are rounded and smooth, which indicates such area was an ancient shoreline of Lake Tahoe. This soil is unlike the mapped Umpa series, and unlike the Jorge-Tahoma soil types due to the wave-influenced substratum. This is an unnamed inclusion (XXX). For slopes 0 to 16%, this soil rates as Class 6, as per Table 4 of the Bailey land capability system.

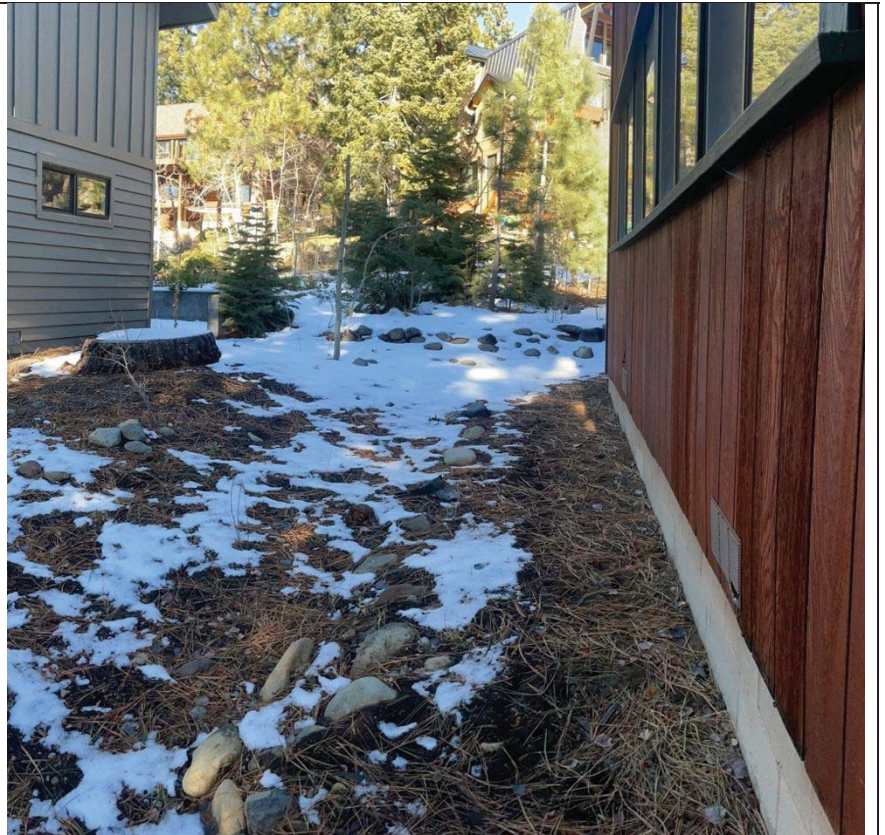
Photo 6 – View west side of residence (reddish brown building at right), where the natural surface appears slightly modified by house construction (circa 1970s) and installation of perimeter BMPs (surface stones in center foreground). For land capability purposes, the natural slopes are relied upon. The slope on this edge of the parcel is 11%. Such slope qualifies this portion of the property as Class 6 for slopes 0 to 16%.

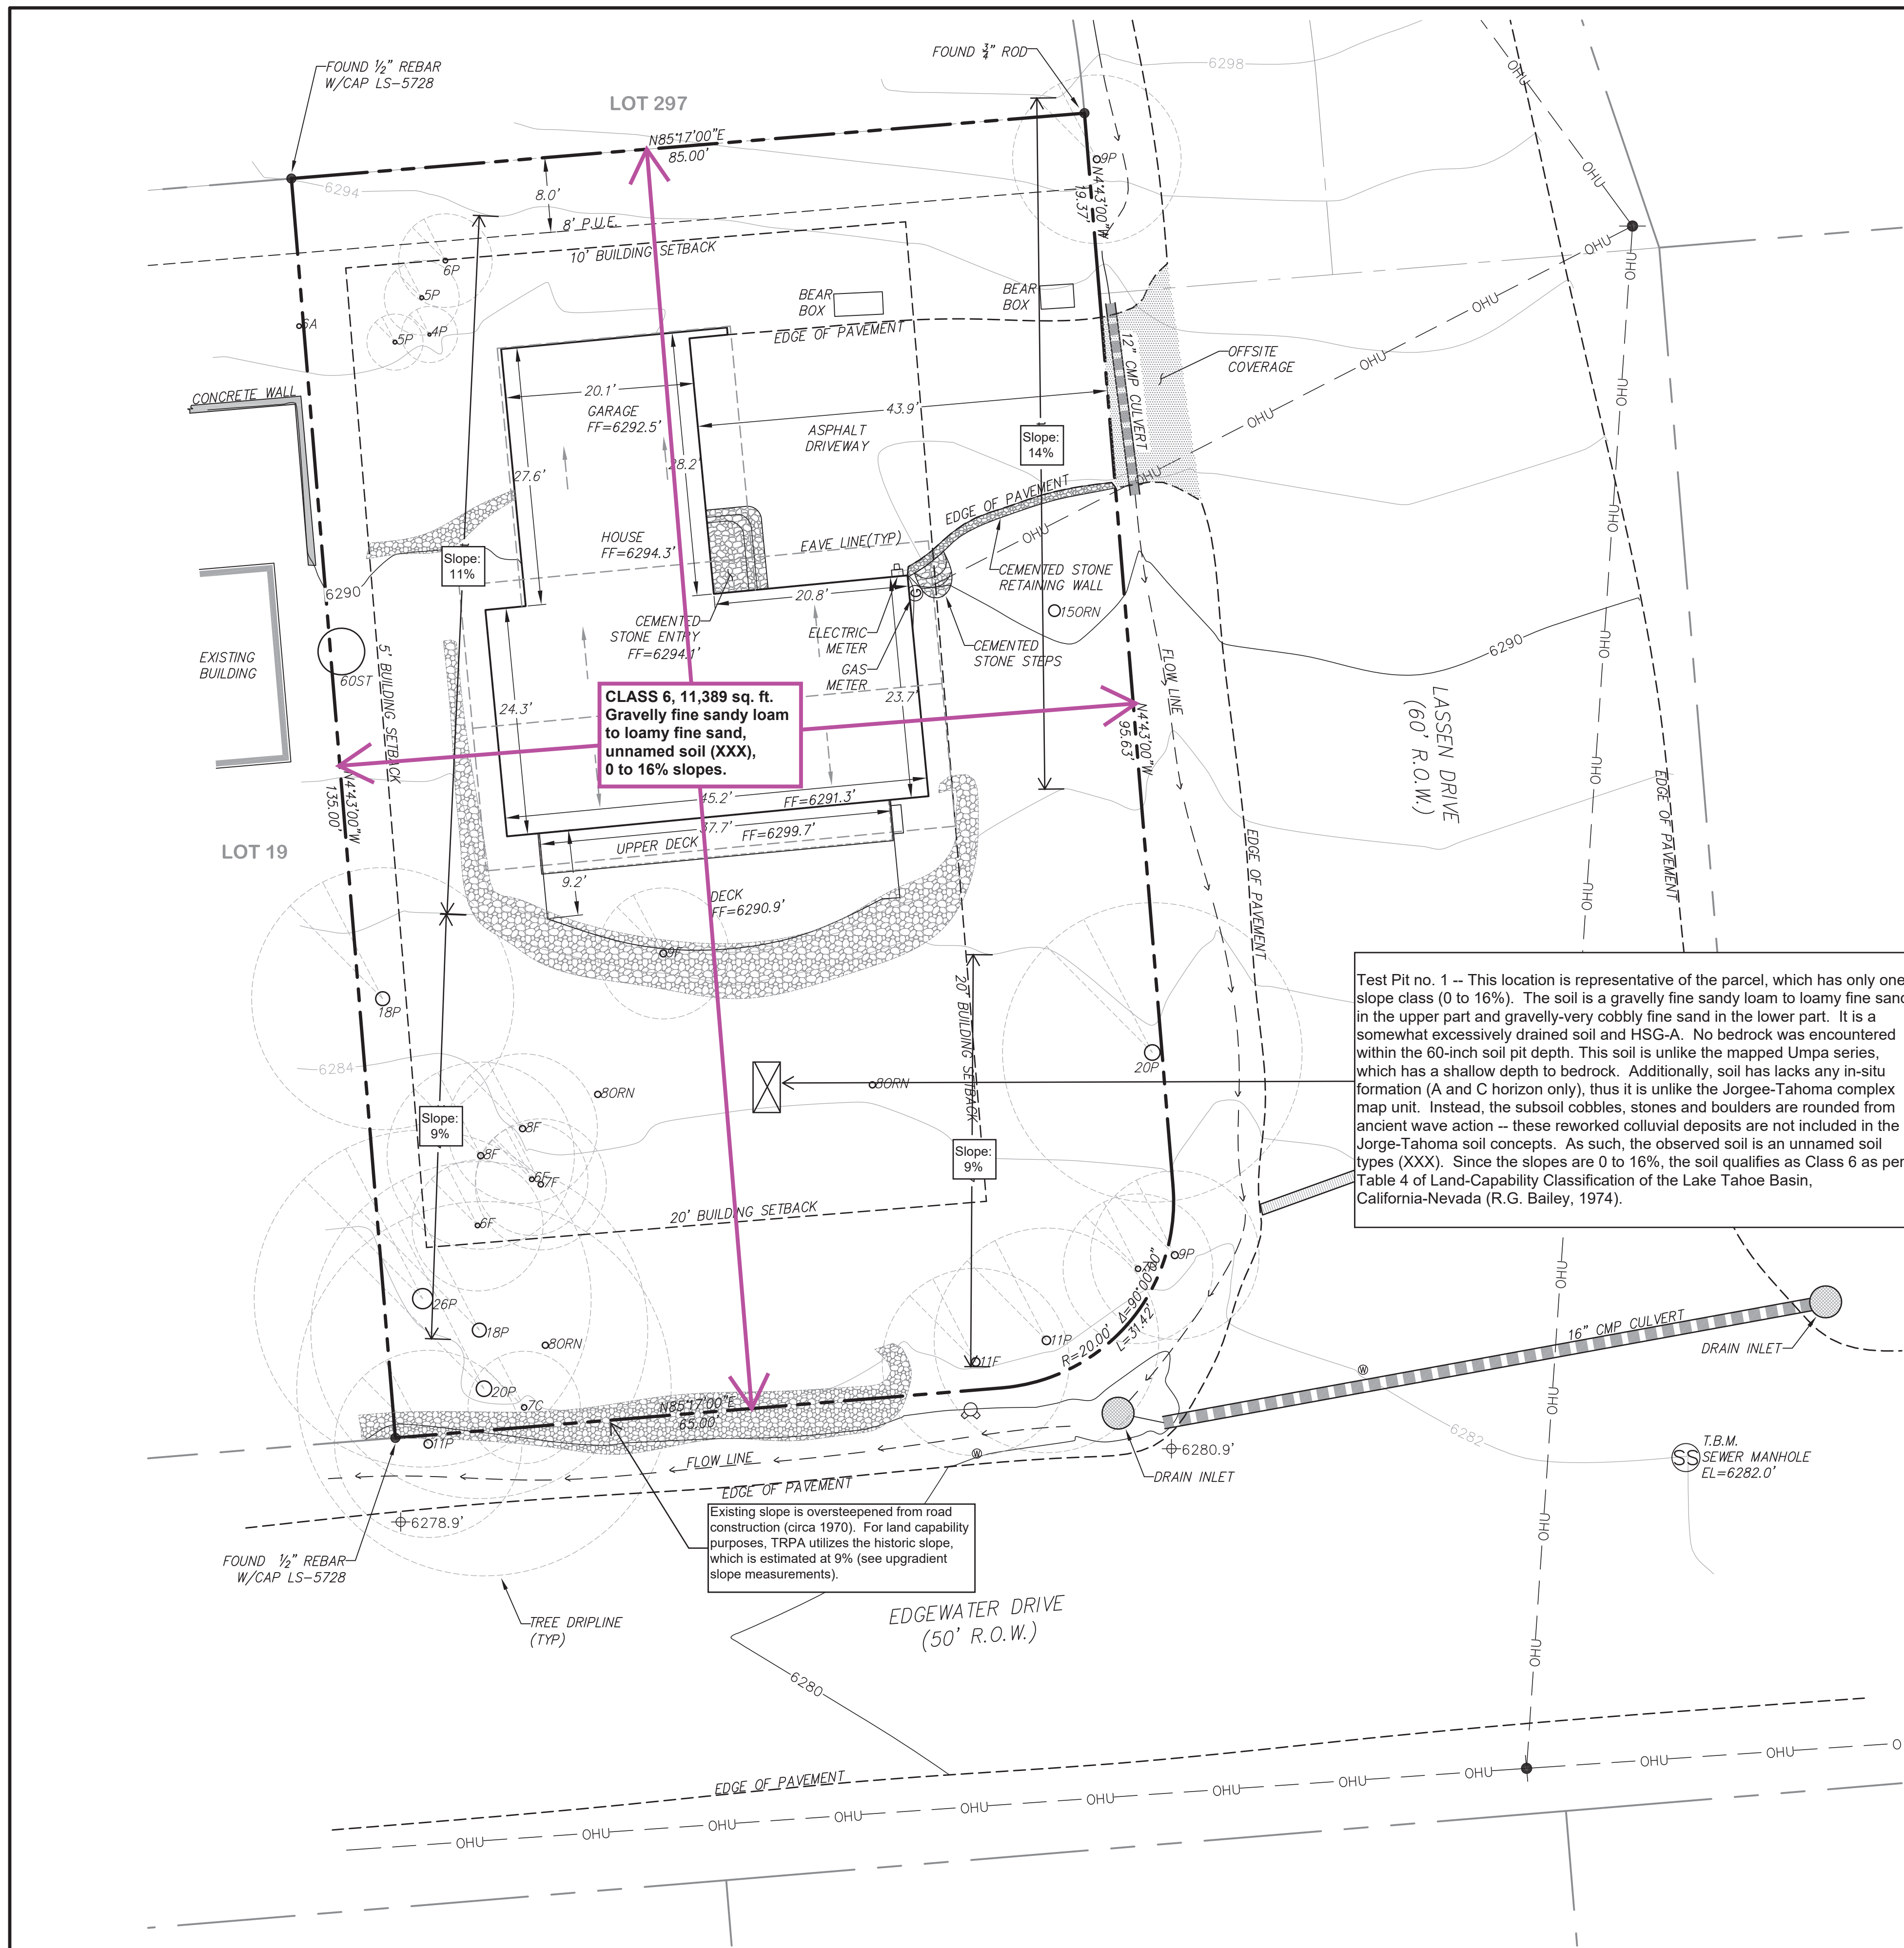
Attachment C  
January 2024 Land Capability Challenge Recommendation Map

**CLASS 6, 11,389 sq. ft.**  
Gravelly fine sandy loam to loamy fine sand, unnamed soil (XXX), 0 to 16% slopes.

Test Pit no. 1 – This location is representative of the parcel, which has only one slope class (0 to 16%). The soil is a gravelly fine sandy loam to loamy fine sand in the upper part and gravelly-very cobbly fine sand in the lower part. It is a somewhat excessively drained soil and HSG-A. No bedrock was encountered within the 60-inch soil pit depth. This soil is unlike the mapped Umpa series, which has a shallow depth to bedrock. Additionally, soil lacks any in-situ formation (A and C horizon only), thus it is unlike the Jorjee-Tahoma complex map unit. Instead, the subsoil cobbles, stones and boulders are rounded from ancient wave action -- these reworked colluvial deposits are not included in the Jorjee-Tahoma soil concepts. As such, the observed soil is an unnamed soil type (XXX). Since the slopes are 0 to 16%, the soil qualifies as Class 6 as per Table 4 of Land-Capability Classification of the Lake Tahoe Basin, California-Nevada (R.G. Bailey, 1974).

Existing slope is oversteepened from road construction (circa 1970). For land capability purposes, TRPA utilizes the historic slope, which is estimated at 9% (see upgradient slope measurements).

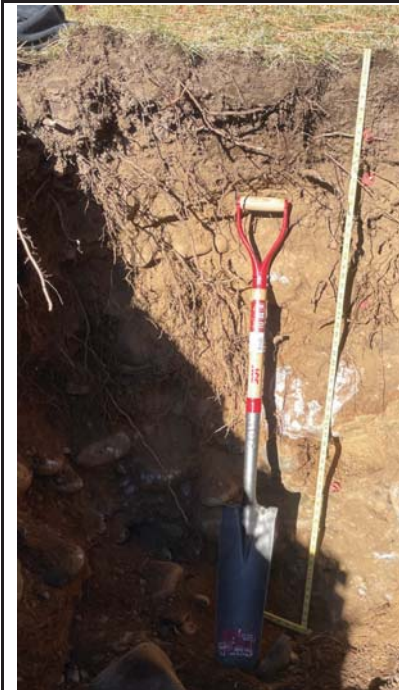
**Photo A – View of soil profile showing bottom depth of 60 inches. Fine root penetration to bottom. No indication of seasonal water table.**

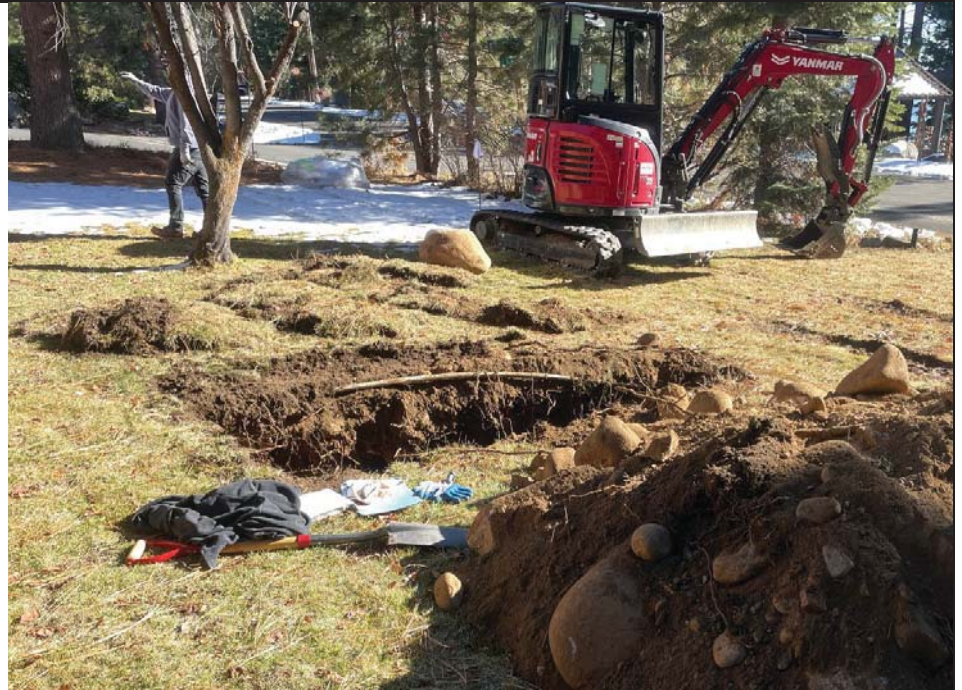
**Photo B – View southeast at Test Pit 1, located 25 feet south of residence (deck), 40 feet west of east property line and 35 feet north of south property line. Pit location is representative of parcel and has a 9% slope. The soil layers are composed of mixed colluvium over ancient beach deposit. Profile has 5 to 20% rounded stones and boulders (lower right corner).**
