STAFF REPORT

Subject: Chesler Land Capability Challenge
179 Mason Court, Douglas County, NV
APN: 1418-34-304-011; TRPA File #: LCAP2023-0289

LAND CAPABILITY ANALYSIS FOR
ANDREW AND ELLEN CHESLER PARCEL
179 Mason Court (Lakeridge Vicinity)
Zephyr Cove, Douglas County, Nev.
APN: 1418-34-304-011

**LAND CAPABILITY ANALYSIS FOR
ANDREW AND ELLEN CHESLER PARCEL
179 MASON COURT, ZEPHYR COVE,
DOUGLAS COUNTY, NEV. (APN 1418-34-304-011)**

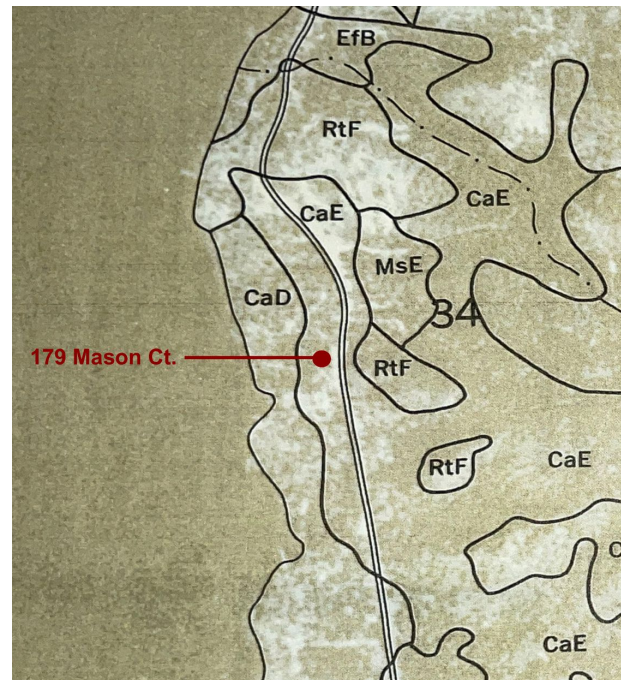
Geologic map (left diagram) indicates vicinity of subject parcel consists of a granite-like plutonic rock (Keg – Granodiorite of The East Peak, Cretaceous) that extends from Lake Tahoe to the crest of the Carson Range. The 1974 soil survey (right diagram) shows presence of Cagwin-Rock outcrops, 15 to 30% slopes (CaE, Class 2), with Cagwin-Rock outcrops, 5 to 15% slopes (CaD, Class 4) closer to Lake Tahoe. The CaE soil type was verified by TRPA for an April 12, 1996 land capability verification (LCV).

As shown on the inset on the previous page, the soils for this vicinity were originally described in Soil Survey of the Lake Tahoe Basin, California-Nevada (Roger, J., 1974). Specifically, Soil Conservation Service (now Natural Resources Conservation Service, NRCS) mapped this vicinity as Cagwin-Rock outcrop, 15 to 30% slopes (CaE), and Cagwin-Rock outcrop, 5 to 15% slopes (CaE), for land further west (downslope) of the subject parcel. Such mapping is a predictive tool based on years of field research that correlates soil formation factors like parent material, landform, slope, aspect, mineralogy, depth, drainage, stoniness, age (weathering) and vegetation patterns. Such mapping does not infer that soil conditions were verified for a particular parcel and natural variability is expected (inclusions of similar and/or associated soils).

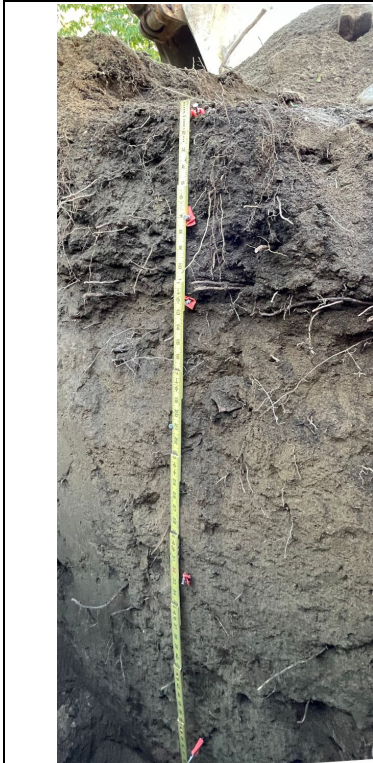
Photo 1. Soil Pit no. 1
(Depth = 60 in.)

When described, the soil was dry to 60 inches (no irrigation, seasonally dry). Profile photos included in Appendix B.

Oi—<0.25-inch; pine needles, twigs, abrupt smooth boundary.

AC—0.25 to 7 inches; very dark grayish brown (10YR 3/2) **fine sandy loam (fill mixed with topsoil)**; very dark brown (10YR 2/2) moist; weak fine granular structure; soft, very friable, slightly sticky, slightly plastic; many fine roots and common medium roots; common interstitial pores; <1% gravels; abrupt smooth boundary. Soil texture influenced by organic matter presence and imported topsoil (for landscaping).

A2—7 to 12 inches; very dark brown (10YR 2/2) **loamy sand (no fill material)**; black (10YR 2/1) moist; weak fine granular structure; soft, loose, nonsticky, nonplastic; many fine roots, many medium roots and few coarse roots; many medium interstitial pores; <1% gravels; abrupt smooth boundary.

Bw1—12 to 21 inches; dark yellowish brown (10YR 3/3) **loamy sand**; dark grayish brown (7.5YR 3/2) moist; weak fine granular structure; soft, loose, nonsticky, nonplastic; common fine roots, common medium roots and few coarse roots; many medium interstitial pores; <1% gravels; clear smooth boundary.

Bw2—21 to 32 inches; dark yellowish brown (10YR 3/3) **loamy sand**; dark grayish brown (10YR 3/2) moist; weak fine granular structure parting to weak fine subangular blocky; soft, loose, nonsticky, nonplastic; common fine roots, few medium roots and few coarse roots; many medium interstitial pores; <1% gravels; clear smooth boundary. No redoximorphic features.

C1—32 to 49 inches; olive brown (2.5Y 4/3) **loamy sand**; dark olive brown (2.5Y 3/3) moist; weak fine subangular structure; soft, loose, nonsticky, nonplastic; few fine roots and few medium roots; common medium interstitial pores; <1% gravels; clear smooth boundary. No redoximorphic features.

C2—49 to 60 inches; light olive brown (2.5Y 5/3) **loamy sand**; olive brown (2.5Y 4/3) moist; massive structure; soft, loose, nonsticky, nonplastic; few fine roots and few medium roots; common medium interstitial pores; <1% cobbles; clear smooth boundary. No redoximorphic features.

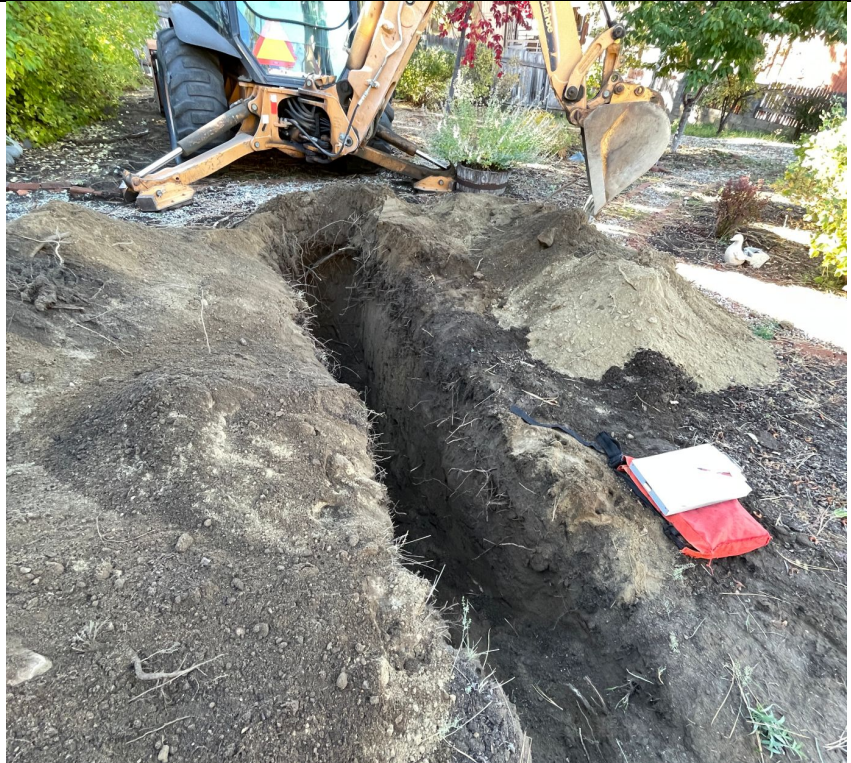
Photo 2. View south at Soil Pit no. 1. Roots extended to bottom of soil pit with no indication of seasonal high water.

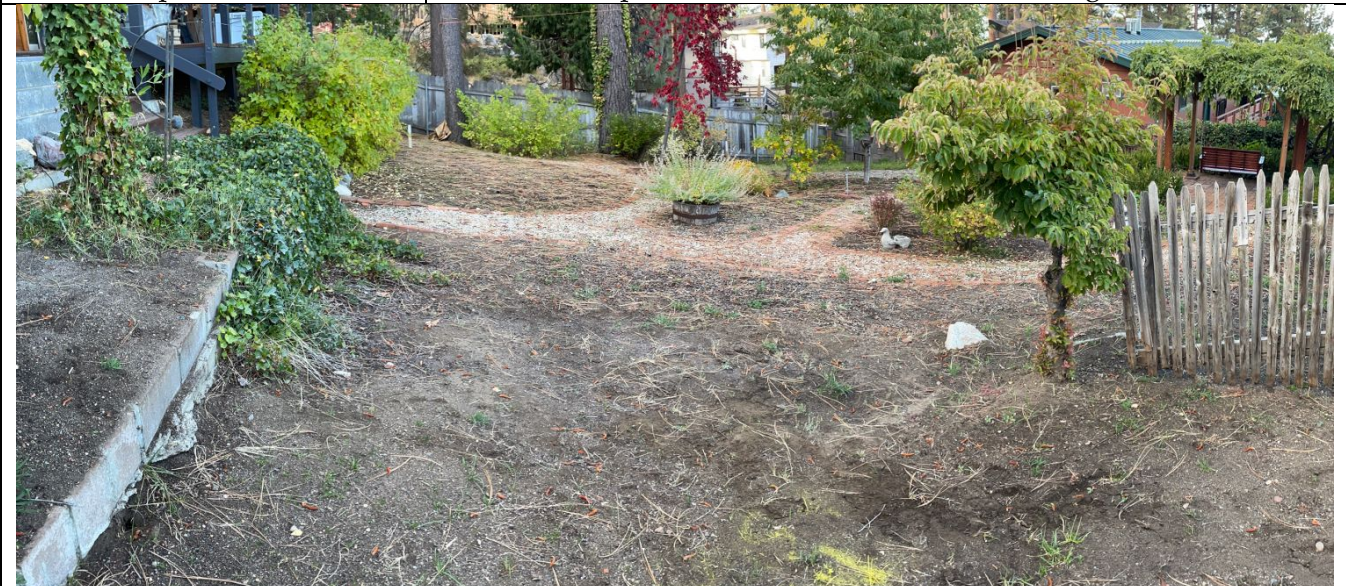
Photo 3. View south by southwest at upper part of backyard, located west of residence (at far left). Residence situated mostly on 21 to 24% slopes, while backyard ranges from 13 to 18% slopes.

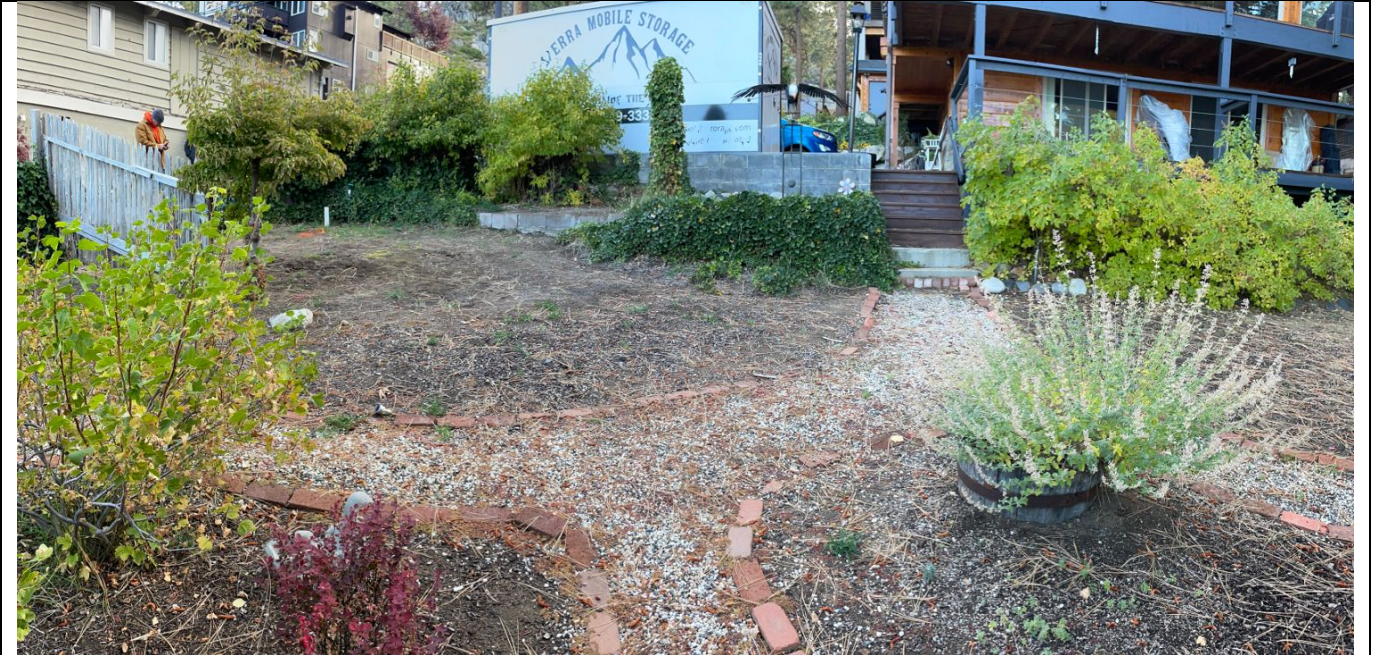
Photo 4. View northeast by east from west-center of backyard (west portion of property). The observed soil conditions were deep, loamy coarse sand textures, plus no root or water limitations.

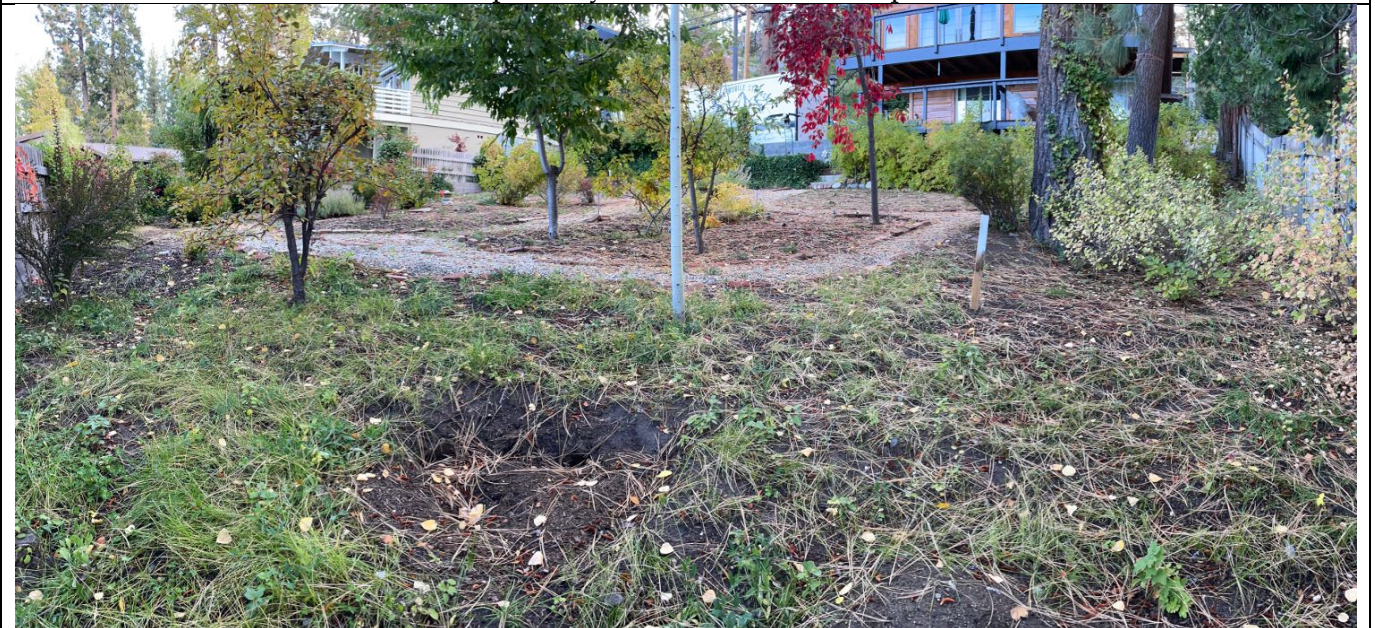
Photo 5. Panoramic view from southwest corner. The foreground is several feet lower than the the soil pit (center-background, below retaining wall). The backyard (west of house) is landscaped with ornamental tree and shrubs, plus several pine and fir trees.

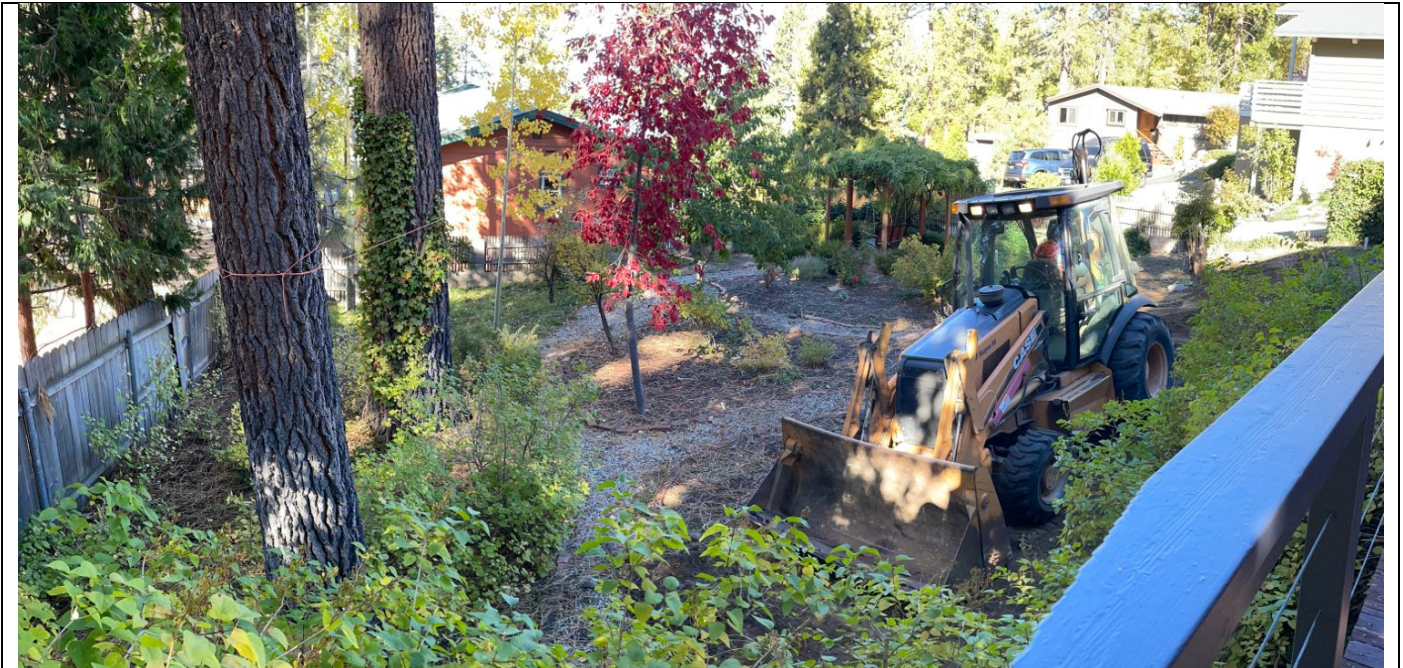
Photo 6. View west by northwest from residence deck. Soil test pit located at opposite (north) end of backhoe on 16% slope.

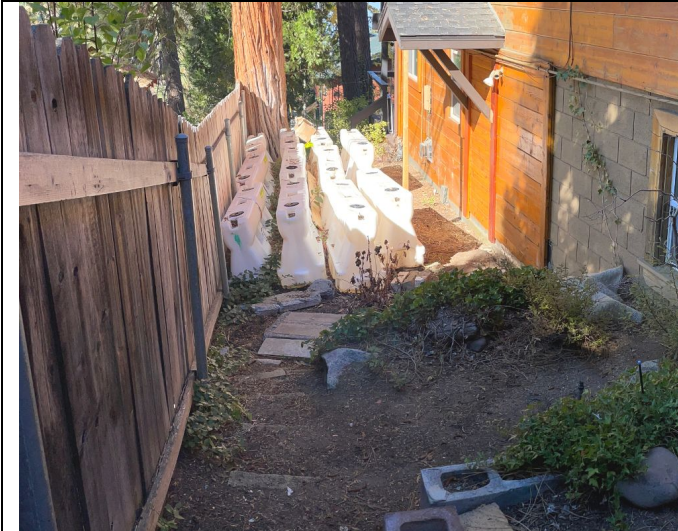
Photo 8. View south along south edge of residence where prior grading occurred.

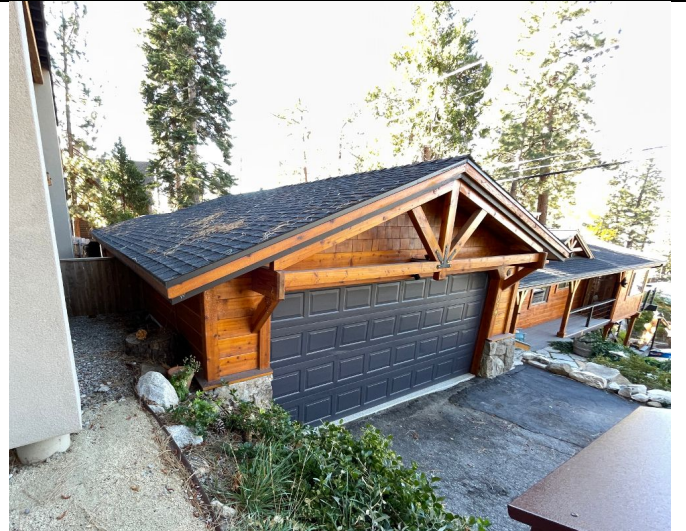
Photo 9. View southwest at east edge of garage which abuts the property line.

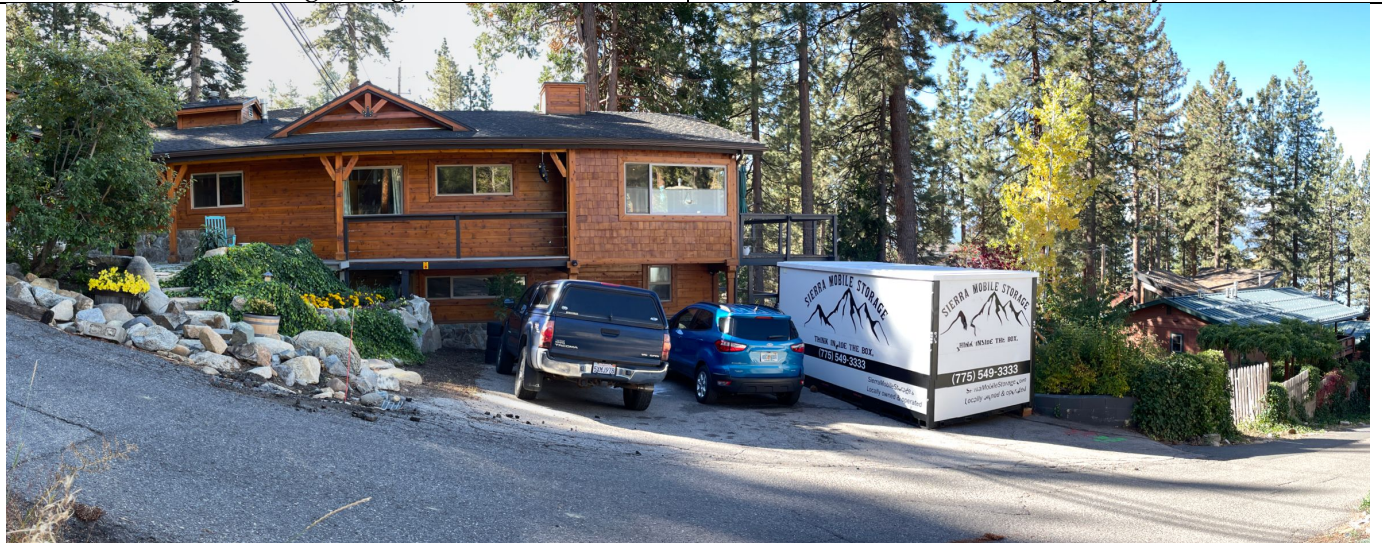
Photo 10. View southwest by west across north side of residence and Mason Court (foreground). A segment of the street is located with subject parcel; however, no land capability rating assigned.
