STAFF REPORT

Subject Wolpe Land Capability Challenge

4127 Verbier Road, Placer County, California APN: 083-450-008, TRPA File no: LCAP2023-0301

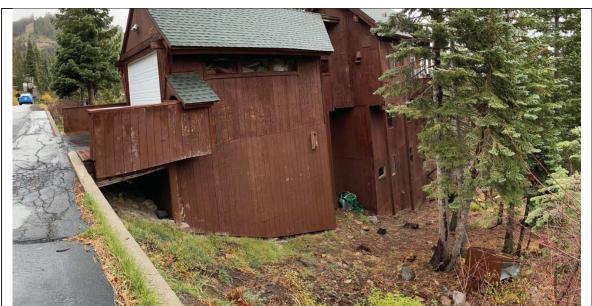
Photo 1 – View east toward residence from west corner of property. Slope immediate downgradient of Verbier Road is artificially steepened. Natural slope on this side of residence is 33%. Tree cover includes white fir, red fir and willow.

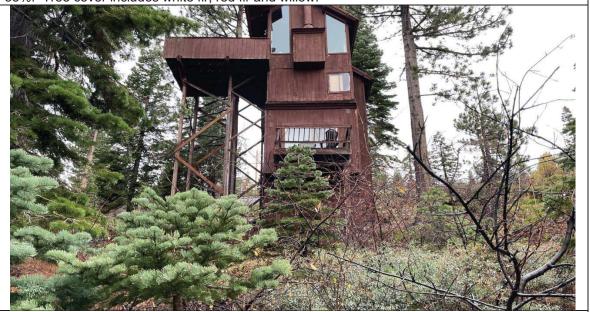
Photo 2 – View northwest toward residence from south-center of parcel. The slope to the left of residence is 33% and 29% to the right. Native understory contains snowberry, Sierra currant, whitethorn, prostrate ceanothus, plus grasses/forbs.

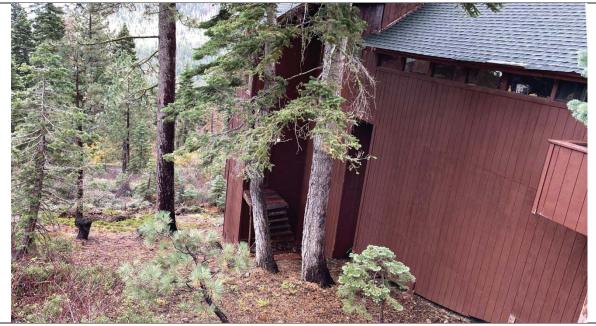
Photo 3 – View to southeast along east side of residence. Ground cover is good with 25 to 35% vegetation and 65 to 75% fir needles, twigs, and leaves. No indication of active erosion.

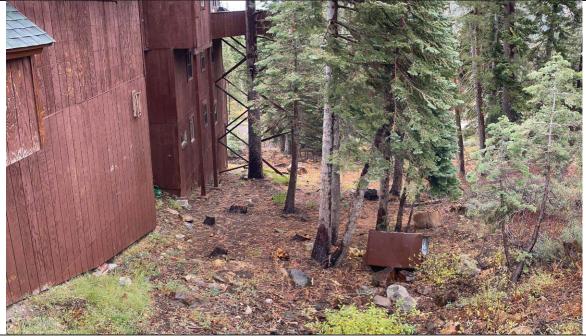
Photo 4 – View to east along west side of residence. This vicinity exhibited more historic ground disturbance, as evident by concrete debris, increased surface stones (side cast during house construction), and less vegetative cover (still no active erosion).

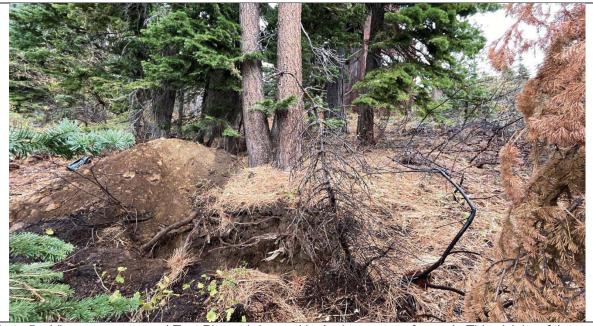
Photo 5 – View to west toward Test Pit no. 1, located in the lower part of parcel. This vicinity of the property has the least disturbance, such as timber harvest. The lower edge of the parcel abuts Courcheval Road, so that slope is artificially steep; whereas, the natural slope is about 26%.

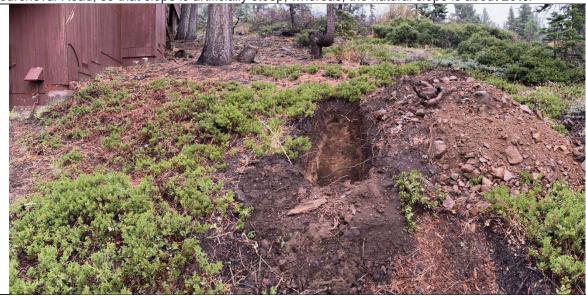
Photo 6 – View to northeast toward Test Pit no. 2, located about 20 feet northeast of the residence. The slope in this vicinity is 29%, which was measured on the adjacent (vacant) parcel at right edge of photo. The land surface immediately surrounding the residence is irregular, presumably a remnant condition after house construction.

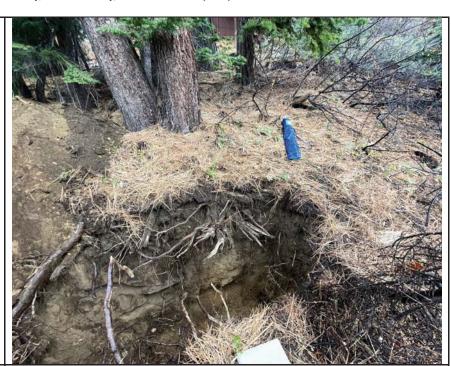
Photo B – View south at Soil Pit 1, located 20 feet northwest of southeast property line and 25 feet southwest of northeast property line. This vicinity has a 26% slope, except parallel to Courchevel Road (artificially steepened). The surface layers are composed of mixed colluvium. Few surface boulders (not attached to bedrock).

Layer	Depth (In.)	Color (moist)	Soil Properties / Features
Oi	0 to 3	Dark brown	Partially decomposed fir needles, twigs, abrupt boundary.
А	3 to 12	Very dark brown (10YR 2/2)	Very gravelly SANDY LOAM, moderate medium granular structure, 40% gravels and 10% cobbles, very friable, slightly plastic, slightly sticky, no redox features, many fine roots, common medium and coarse roots; many fine interstitial pores, abrupt boundary.
Bw1	12 to 22	Very dark brown (7.5YR 2.5/2)	Very gravelly SANDY LOAM, moderate medium granular structure, 35% gravels, 10% cobbles, 2% stones/boulders, friable, slightly plastic, slightly sticky, no redox features, many fine, medium and coarse roots; many fine interstitial pores, clear boundary.
Bw2	22 to 35	Very dark brown (7.5YR 2.5/3)	Very gravelly SANDY LOAM, weak fine subangular blocky structure, 30% gravels, 15% cobbles, 5% stones/boulders, friable, slightly plastic, slightly sticky, no redox features, common fine and coarse roots, many medium roots; many fine interstitial pores, clear boundary.

С	35 to 46	Dark brown (7.5YR 3/4)	Gravelly-Cobbly SANDY LOAM, massive structure, 10% gravels, 20% cobbles, 5% stones/boulders, slightly hard, slightly plastic, slightly sticky, no redox features, few fine and coarse roots, common medium roots; many fine interstitial pores.
Cr	>46	N/A	Boulders too large to remove; possible upper extent of bedrock.

Soil does not match 1974 soil survey (Rock land, Ra). Onsite soil conditions are less rocky in both upper and lower parts. Additionally, soils onsite have a cambic horizon (Bw), which formed by parent material remaining stable for vegetation growth (such as mature conifer forest). The observed soil also lacks the subsurface silica-cemented layer (that restricts drainage) that is present in the Tallac series. Soil characteristics also do not resembles Jorge-Tahoma very stony, sandy loam, 15 to 30% slopes (JwE) or Meiss cobbly loam (MxE). This unnamed soil is well drained (HSG-B). In accordance with the Land-Capability Classification of the Lake Tahoe Basin (Bailey, 1974), unnamed soils (designated XXX) with slopes 30 to 50% qualify as Class 2, while slopes 16 to 30% qualify as Class 4.

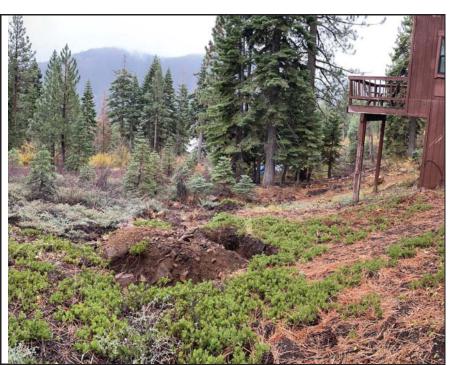
Photo D – View south at Soil Pit 1, located 70 feet southeast of northwest property line and 5 feet southwest of northeast property line. This vicinity has a 29% slope, except parallel to Verbier Road (artificially steepened). The surface layers are composed of mixed colluvium. Few surface boulders (not attached to bedrock).

Layer	Depth (In.)	Color (moist)	Soil Properties / Features
Oi	0 to 1	Dark brown	Partially decomposed fir needles, twigs, abrupt boundary.
A1	1 to 11	Very dark brown (10YR 2/2)	Gravelly SANDY LOAM, moderate fine granular structure, 25% gravels, 1% cobbles, 1% stones; very friable, slightly plastic, slightly sticky, no redox features, many fine roots, common medium roots, and few coarse roots; many fine interstitial pores, clear boundary.
A2	11 to 20	Very dark brown (10YR 2/2)	Gravelly SANDY LOAM, weak fine granular structure, 20% gravels, 10% cobbles, 1% stones, friable, slightly plastic, slightly sticky, no redox features, many fine and medium roots, few coarse roots; many fine interstitial pores, clear boundary.
Bw	20 to 33	Very dark brown (7.5YR 3/3)	Very gravelly-cobbly SANDY LOAM, weak fine subangular blocky structure, 25% gravels, 20% cobbles, 10% stones, friable, slightly plastic, slightly sticky, no redox features, common fine and medium roots, few coarse roots; many fine interstitial pores, clear boundary.

С	33 to 52	Dark brown (7.5YR 3/4)	Ver gravelly-cobbly SANDY LOAM, massive structure, 30% gravels, 20% cobbles, 20% stones/boulders, slightly hard, slightly plastic, slightly sticky, no redox features, few fine and medium roots; many fine interstitial pores.
Cr	>52 in.	N/A	Boulders too large to remove; possible upper extent of bedrock.

Soil does not match 1974 soil survey (Rock land, Ra). Onsite soil conditions are less rocky in both upper and lower parts. Additionally, soils onsite have a cambic horizon (Bw), which formed by parent material remaining stable for vegetation growth (such as mature conifer forest). The observed soil also lacks the subsurface silica-cemented layer (that restricts drainage) that is present in the Tallac series. Soil characteristics also do not resembles Jorge-Tahoma very stony, sandy loam, 15 to 30% slopes (JwE) or Meiss cobbly loam (MxE). This unnamed soil is well drained (HSG-B). In accordance with the Land-Capability Classification of the Lake Tahoe Basin (Bailey, 1974), unnamed soils (designated XXX) with slopes 30 to 50% qualify as Class 2, while slopes 16 to 30% qualify as Class 4.
