STAFF REPORT

Subject: Oak Angle LLC Land Capability Challenge, 1054 Tahoe Boulevard, Washoe County, NV, APN 130-152-08, TRPA File Number LCAP2022-0440

PHOTOGRAPHS (Addendum to APN 130-152-08, August 4, 2022 Staff Summary)

Attachment D Analysis of historic slopes from site topo

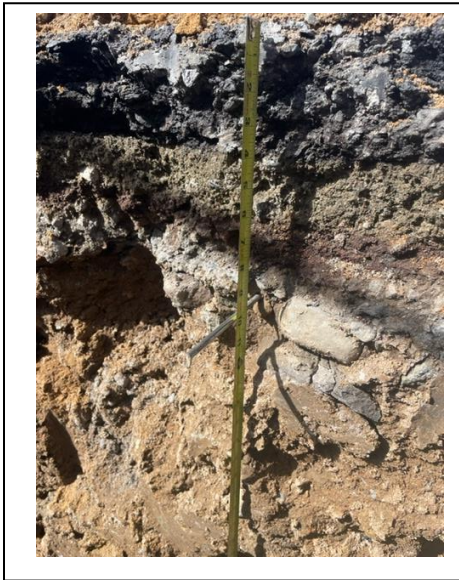
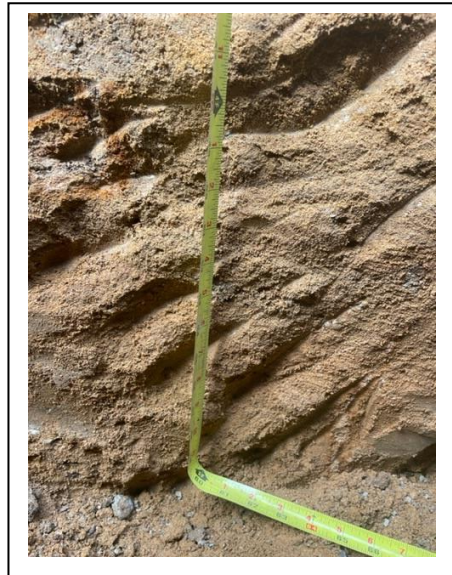
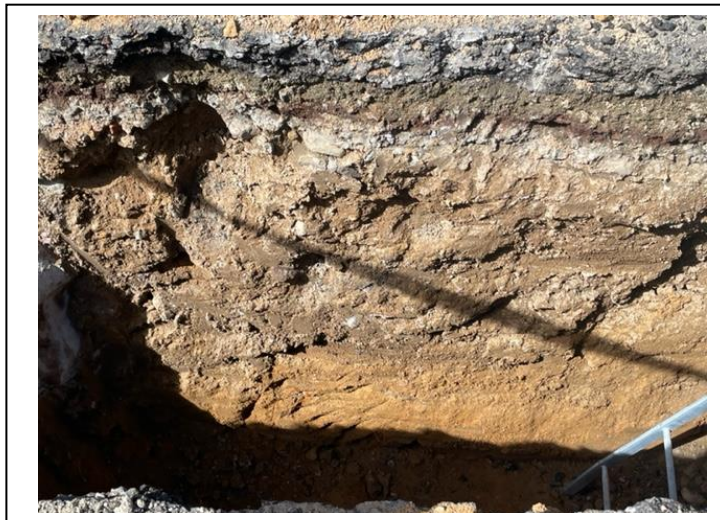
130-152-08 -A:

Photographs; Clockwise from top left, Pit A Upper section; Pit A, lower section; Pit A looking into pit.

Human-altered soil: Surface is covered with asphalt, with road gravels to 9 inches. Up to 14 feet of soil has been removed in this area for an old pit and fill material is evident over the older natural soil which is present at 42 inches below the existing surface.

Capability Class: Class 6.

^Bwu 9 to 42 inches; gravelly sandy clay loam, dark yellowish brown (10YR 4/4) moist; strong medium subangular blocky structure; moderately hard, firm, slightly sticky and slightly plastic; common very fine to fine irregular pores; 30 percent gravel; clear smooth boundary.

Cb 42 to 60+ inches; sandy loam, yellowish brown (10YR 5/4) moist; massive; soft, very friable, slightly sticky and slightly plastic; many very fine and fine irregular pores; 10 percent gravel.

Soil Pit A has 4 inches of asphalt over 4 inches of roadbed gravel, over 33 inches of fill material. The natural soil surface was removed, and fill was subsequently placed on top. Natural soil is present below 42 inches. The texture of the fill material is very gravelly sandy clay loam. The texture of the natural soil is sandy loam with few rock fragments. There are no roots in this soil due to the broad coverage of asphalt, but a root or water restricting barrier was not encountered. This soil is very deep, well drained, and is a member of Soil Hydrologic Group B. There is no vegetation in the vicinity of Pit A. Pit B was excavated on the cut back to find a more natural soil condition. However, the surface soil has been excavated or eroded away. The existing surface soil texture is sandy clay loam, with loamy sand, and sandy loam subsurface textures. The vegetation on the edges of this parcel is dominated by and open Jeffrey pine forest with greenleaf manzanita and antelope bitterbrush in the understory.

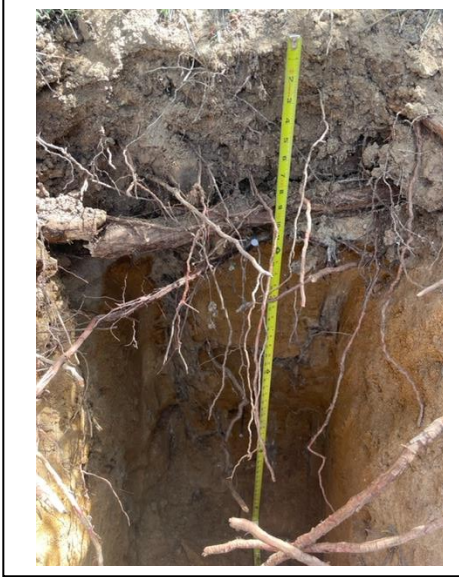
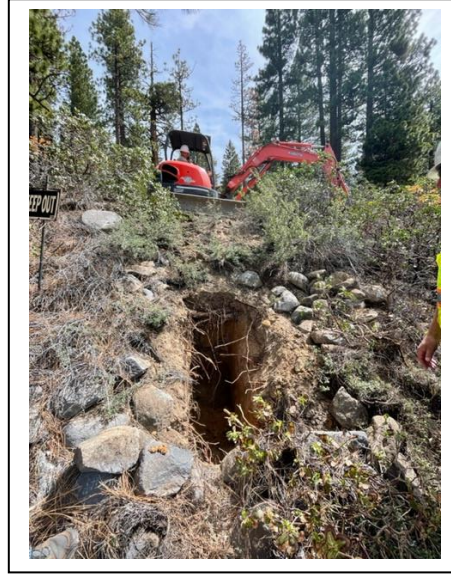
130-152-08 -B:

Photographs: Pit B, and view of Pit B in cut area

Human-altered soil: This pit was excavated near the top of the cutback in an attempt to find the natural soil on this parcel. This pit does have natural soil, but the upper several feet was removed when the pit was excavated.

Capability Class: Class 2 based on existing cut slope, but Class 6 based on historic slopes

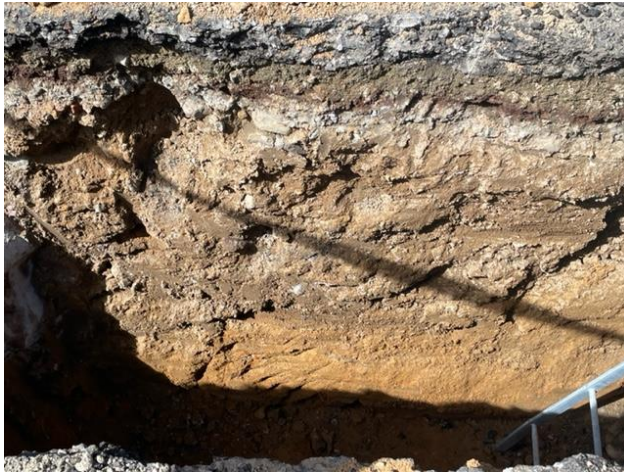
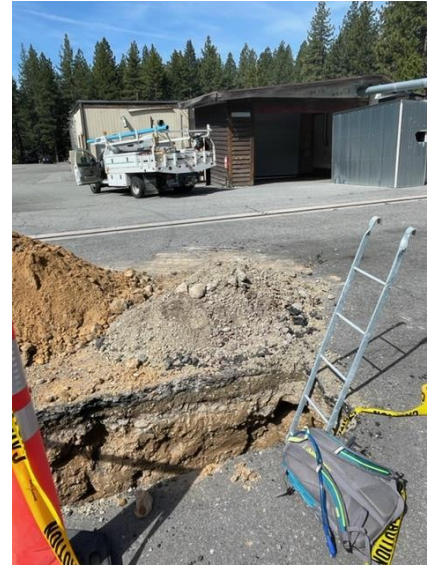
Photo 1 – a. Pit A. Photo 1- b. View from east to west over Pit A.

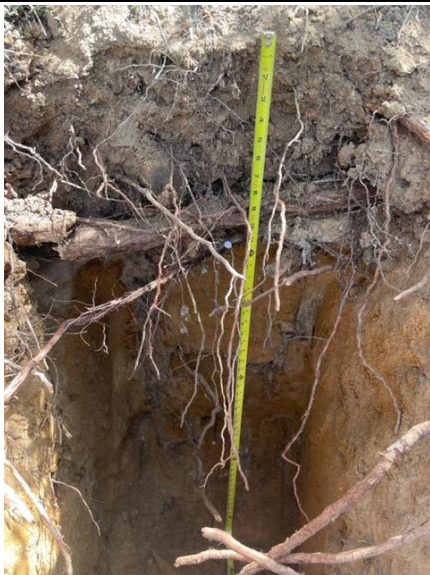
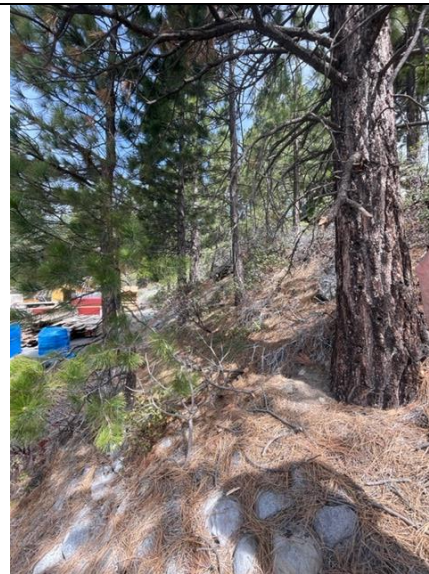
Photo 2 – a. Pit B. Photo 2 – b View from below Pit B to north.

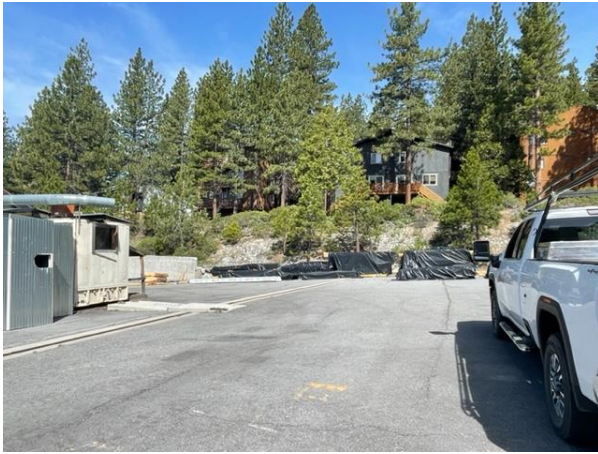
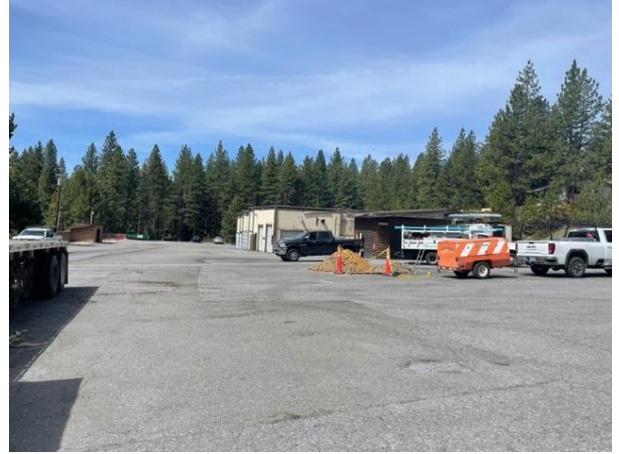
Photo 3 – a. View from Pit A to the north. Photo 3- b. View from east to west over Pit A.

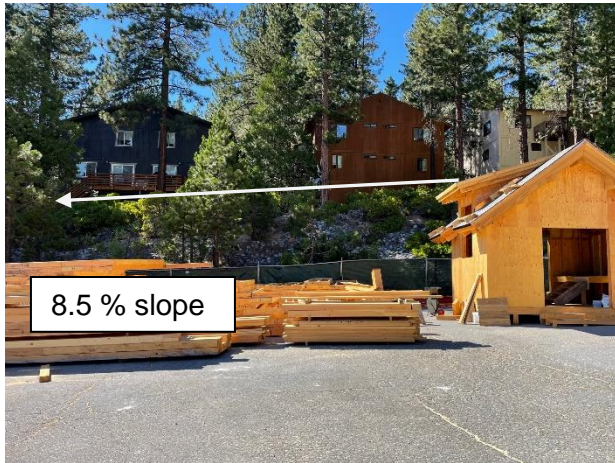
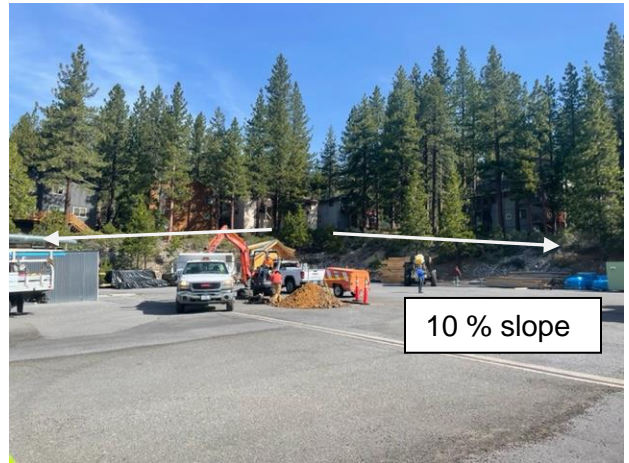
Photo 4 – a. Natural slopes to the north with existing/natural slopes of 8 to 9 percent. 4 b Natural slopes to the east with existing natural slopes of 10 to 11 percent.

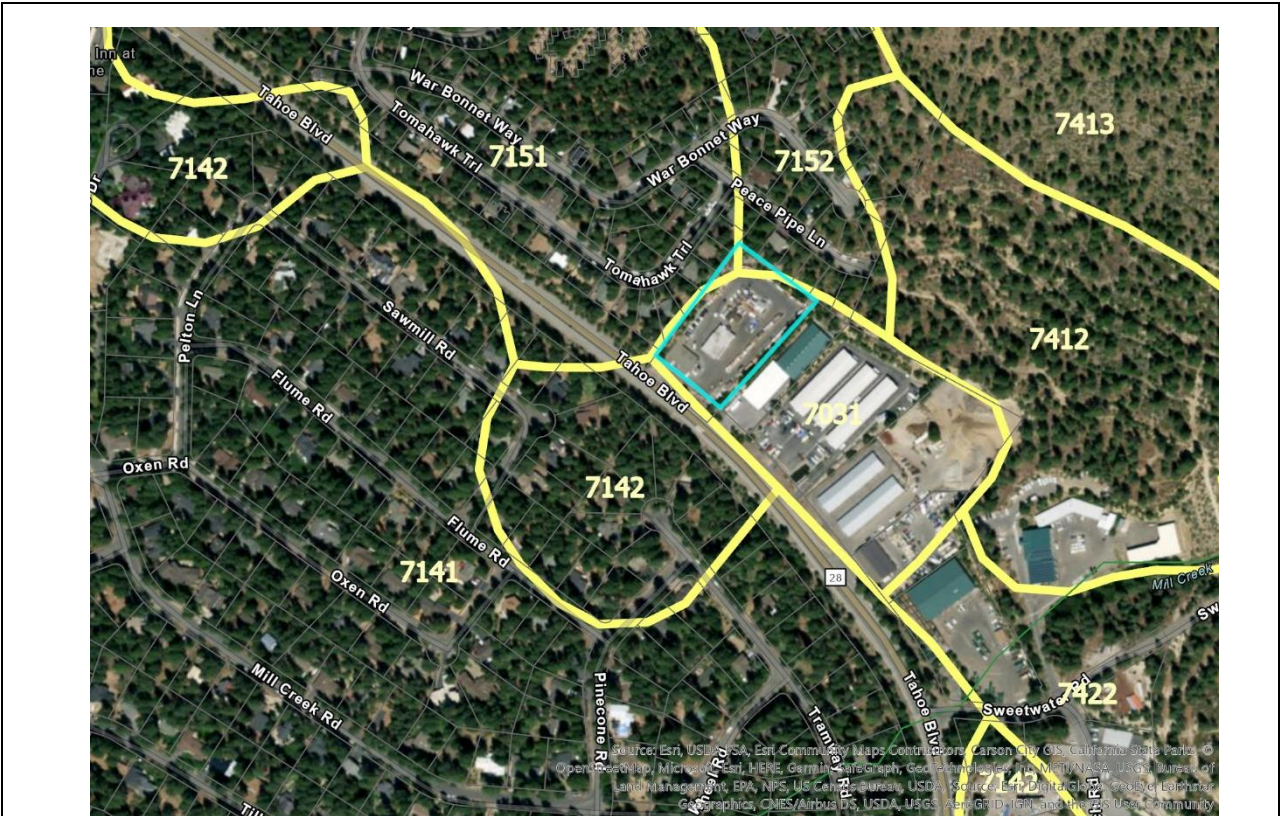
Image 3 – 2007 Soil Survey mapunits in yellow. The parcel remains mapped as 7031- pits and dumps mapunit. The area where UmE, Umpa 15 to 30 percent slopes (Class 3) was mapped is now mapped as 7151- Jorge 5 to 15 percent slopes (Class 6) and 7152- Jorge 15 to 30 percent slopes (Class 4). Mapunits 7142 – Inville 9 to 15 percent slopes (Class 6) and 7141-Inville 2 to 9 percent slopes (Class 6) are mapped below the parcel. Mapunit 7422- Cassenai- 15 to 30 percent slopes (Class 4) is mapped to the southeast of the pits mapunit.

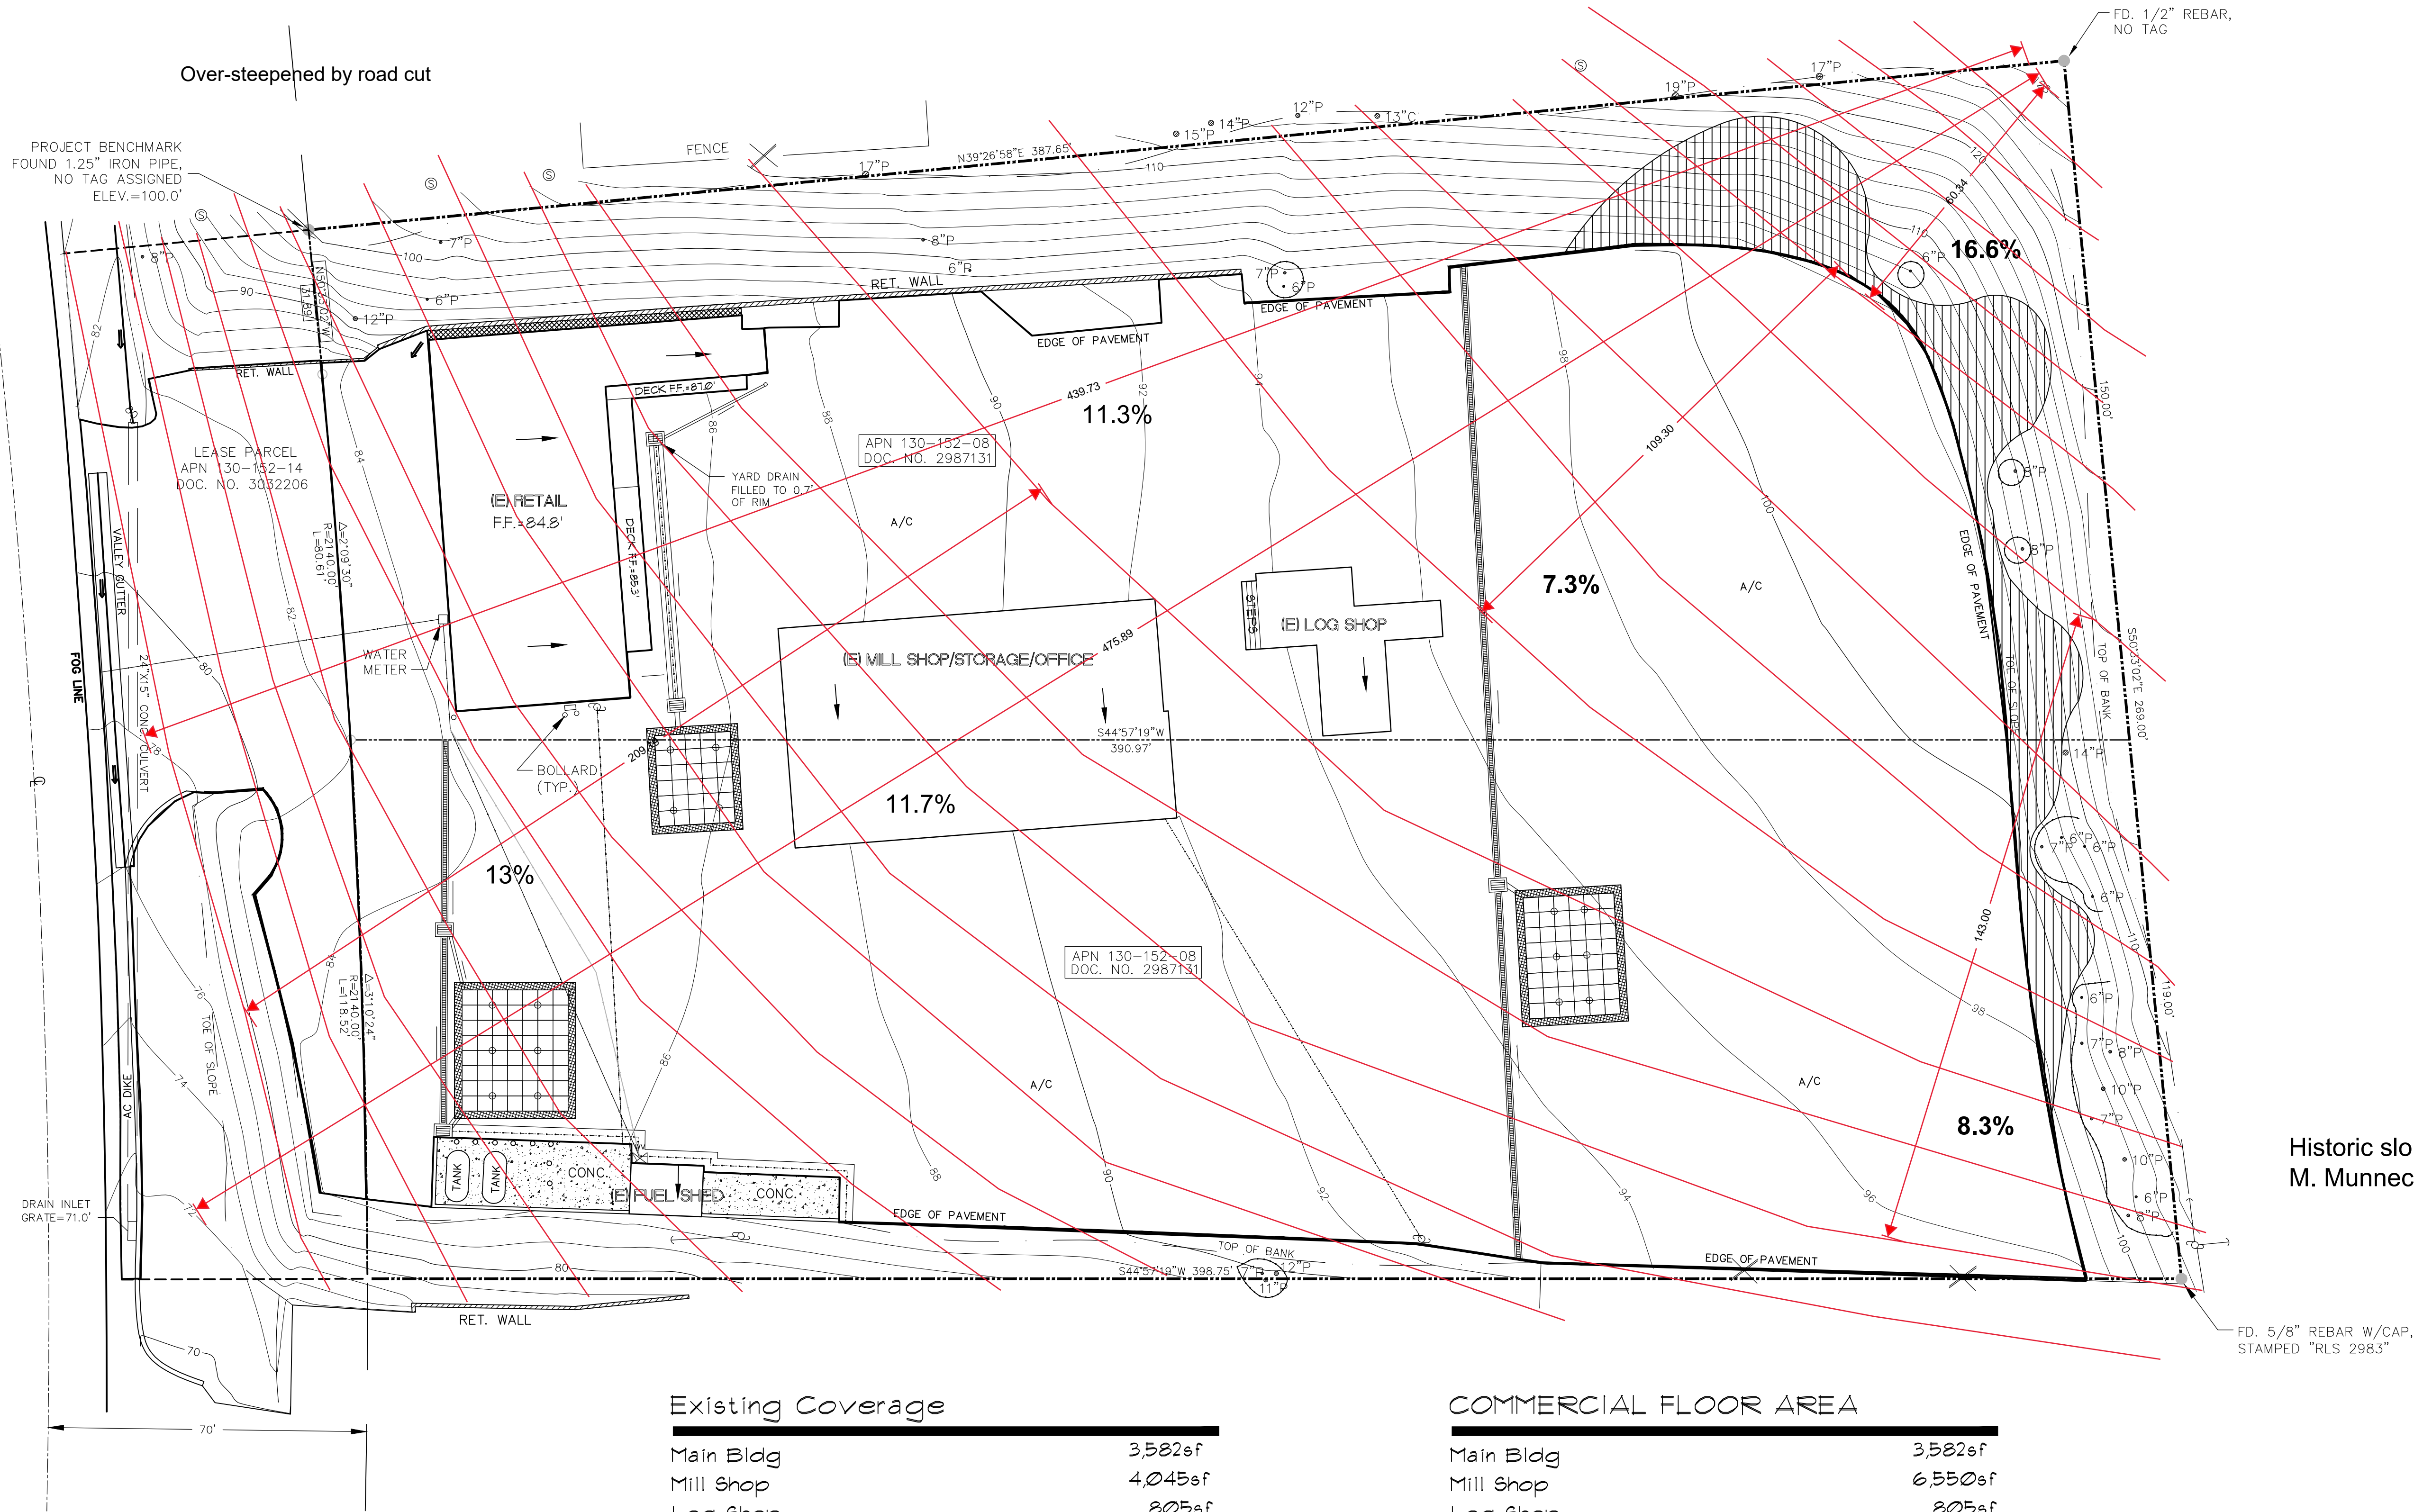
Historic slope interpretation
M. Munnecke 7/21/2022

EXISTING SITE PLAN
SCALE: 1:20

Slope Determination	5 to 60 percent existing slopes and 7 to 17 percent historic slopes
TRPA Conclusion(s)	TRPA concurs with consultants' determination and rationale above.
Applicable Area	See parcel map for soil delineations.
